townhall Prievoz

The building in question is located in Prievoz, once a small suburban village that was annexed to Bratislava in 1946. At the beginning of the 20th century, Prievoz grew rapidly due to the influx of new workers employed in Bratislava's factories. For this reason, a new municipal town hall was built in 1932, based on a design by Christian Ludwig and Augustin Danielis. Their design was inspired by Palladian architecture, with the town hall bears a striking resemblance to Villa Rotonda. The core concept featured a representative single-story building with a central circular foyer covered by a dome, fronted by a representative forecourt. The project likely underwent several changes during the design phase, as the Notary's House was added to the town hall from the east to serve as residential quarters, thereby disrupting the original concept of symmetry.

The current proposal addresses the needs of the Ružinov district, which intends to establish representative spaces and a wedding or lecture hall within the town hall. In our renovation design, we chose two different approaches; while the complex as a whole was perceived as more valuable, we approached both of its parts

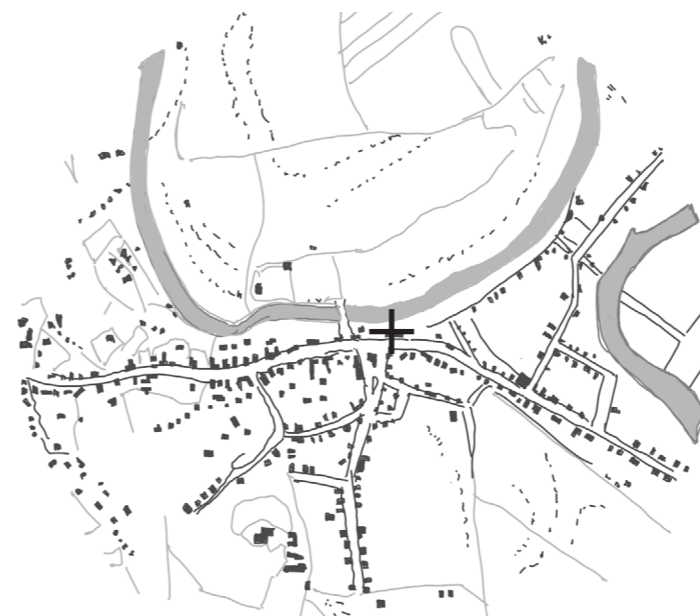
1945

On the map, we can see the already standing town hall along with the Notary's House. The Town Hall Square is complemented by the Evangelical Church. The banks of the Danube are connected by a concrete bridge; the ferry service was no longer in operation.

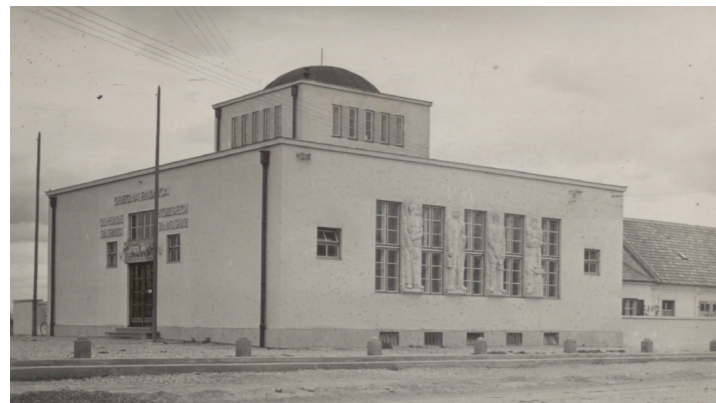
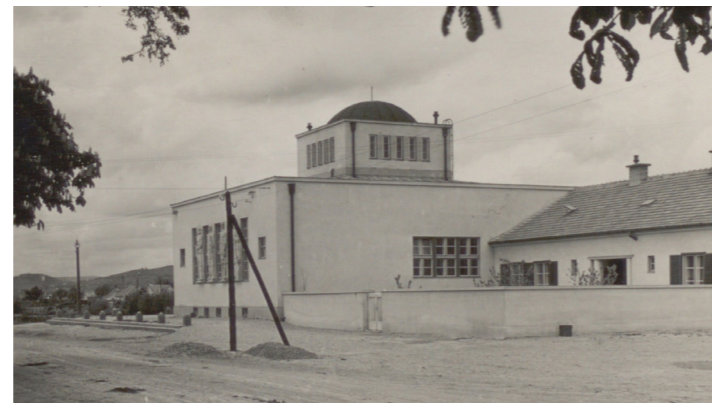
1932\_Christian Ludwig photographs

The town hall has a simple, purist appearance typical of Functionalism. It is built on a square footprint and has the character of a low, horizontal single-story building. It features relief decoration on its southern and western facades.

In the photograph from 1932, the surroundings of the town hall still retain a rural or semi-urban character. In front of the building is a forecourt bordered by bollards. We can see the unpaved surface of Mierová Street.

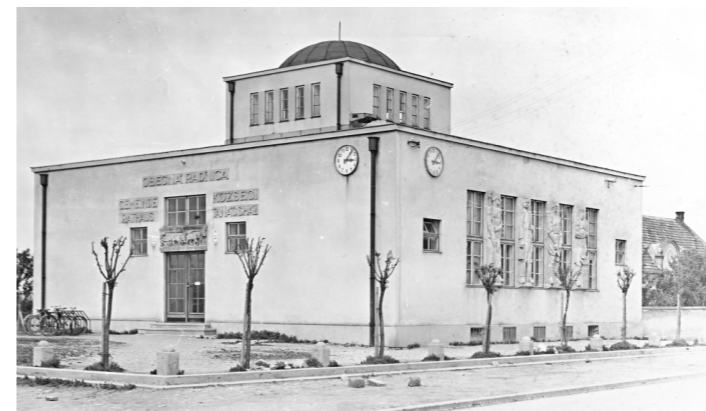
Early 1940s\_Müller family collection

Three new clocks facing Mierová Street were added on three sides of the building. The dirt road was transformed into a paved street. New black locust trees were planted along the border of the forecourt between the bollards.

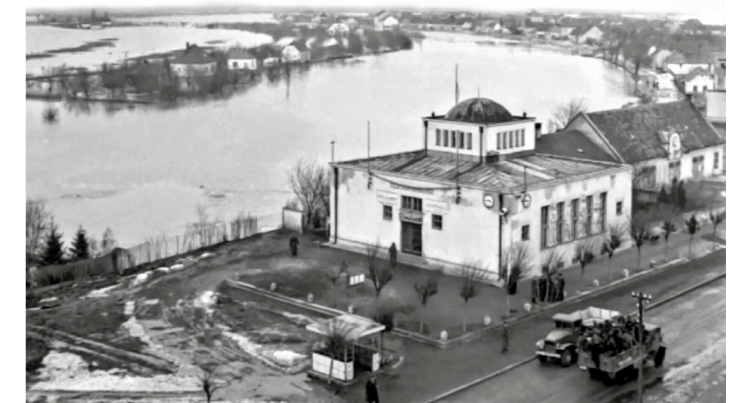
1947\_Photograph by Anton Tarkoš

The photograph captures the former town hall in Prievoz a few years after World War II, as a result of which the Hungarian and German inscriptions were removed. Flagpoles were added. In front of the forecourt, there is a transit stop with an open public space. In the background, one of the branches of the flooded Danube can be seen—today's Gagarinova Street.

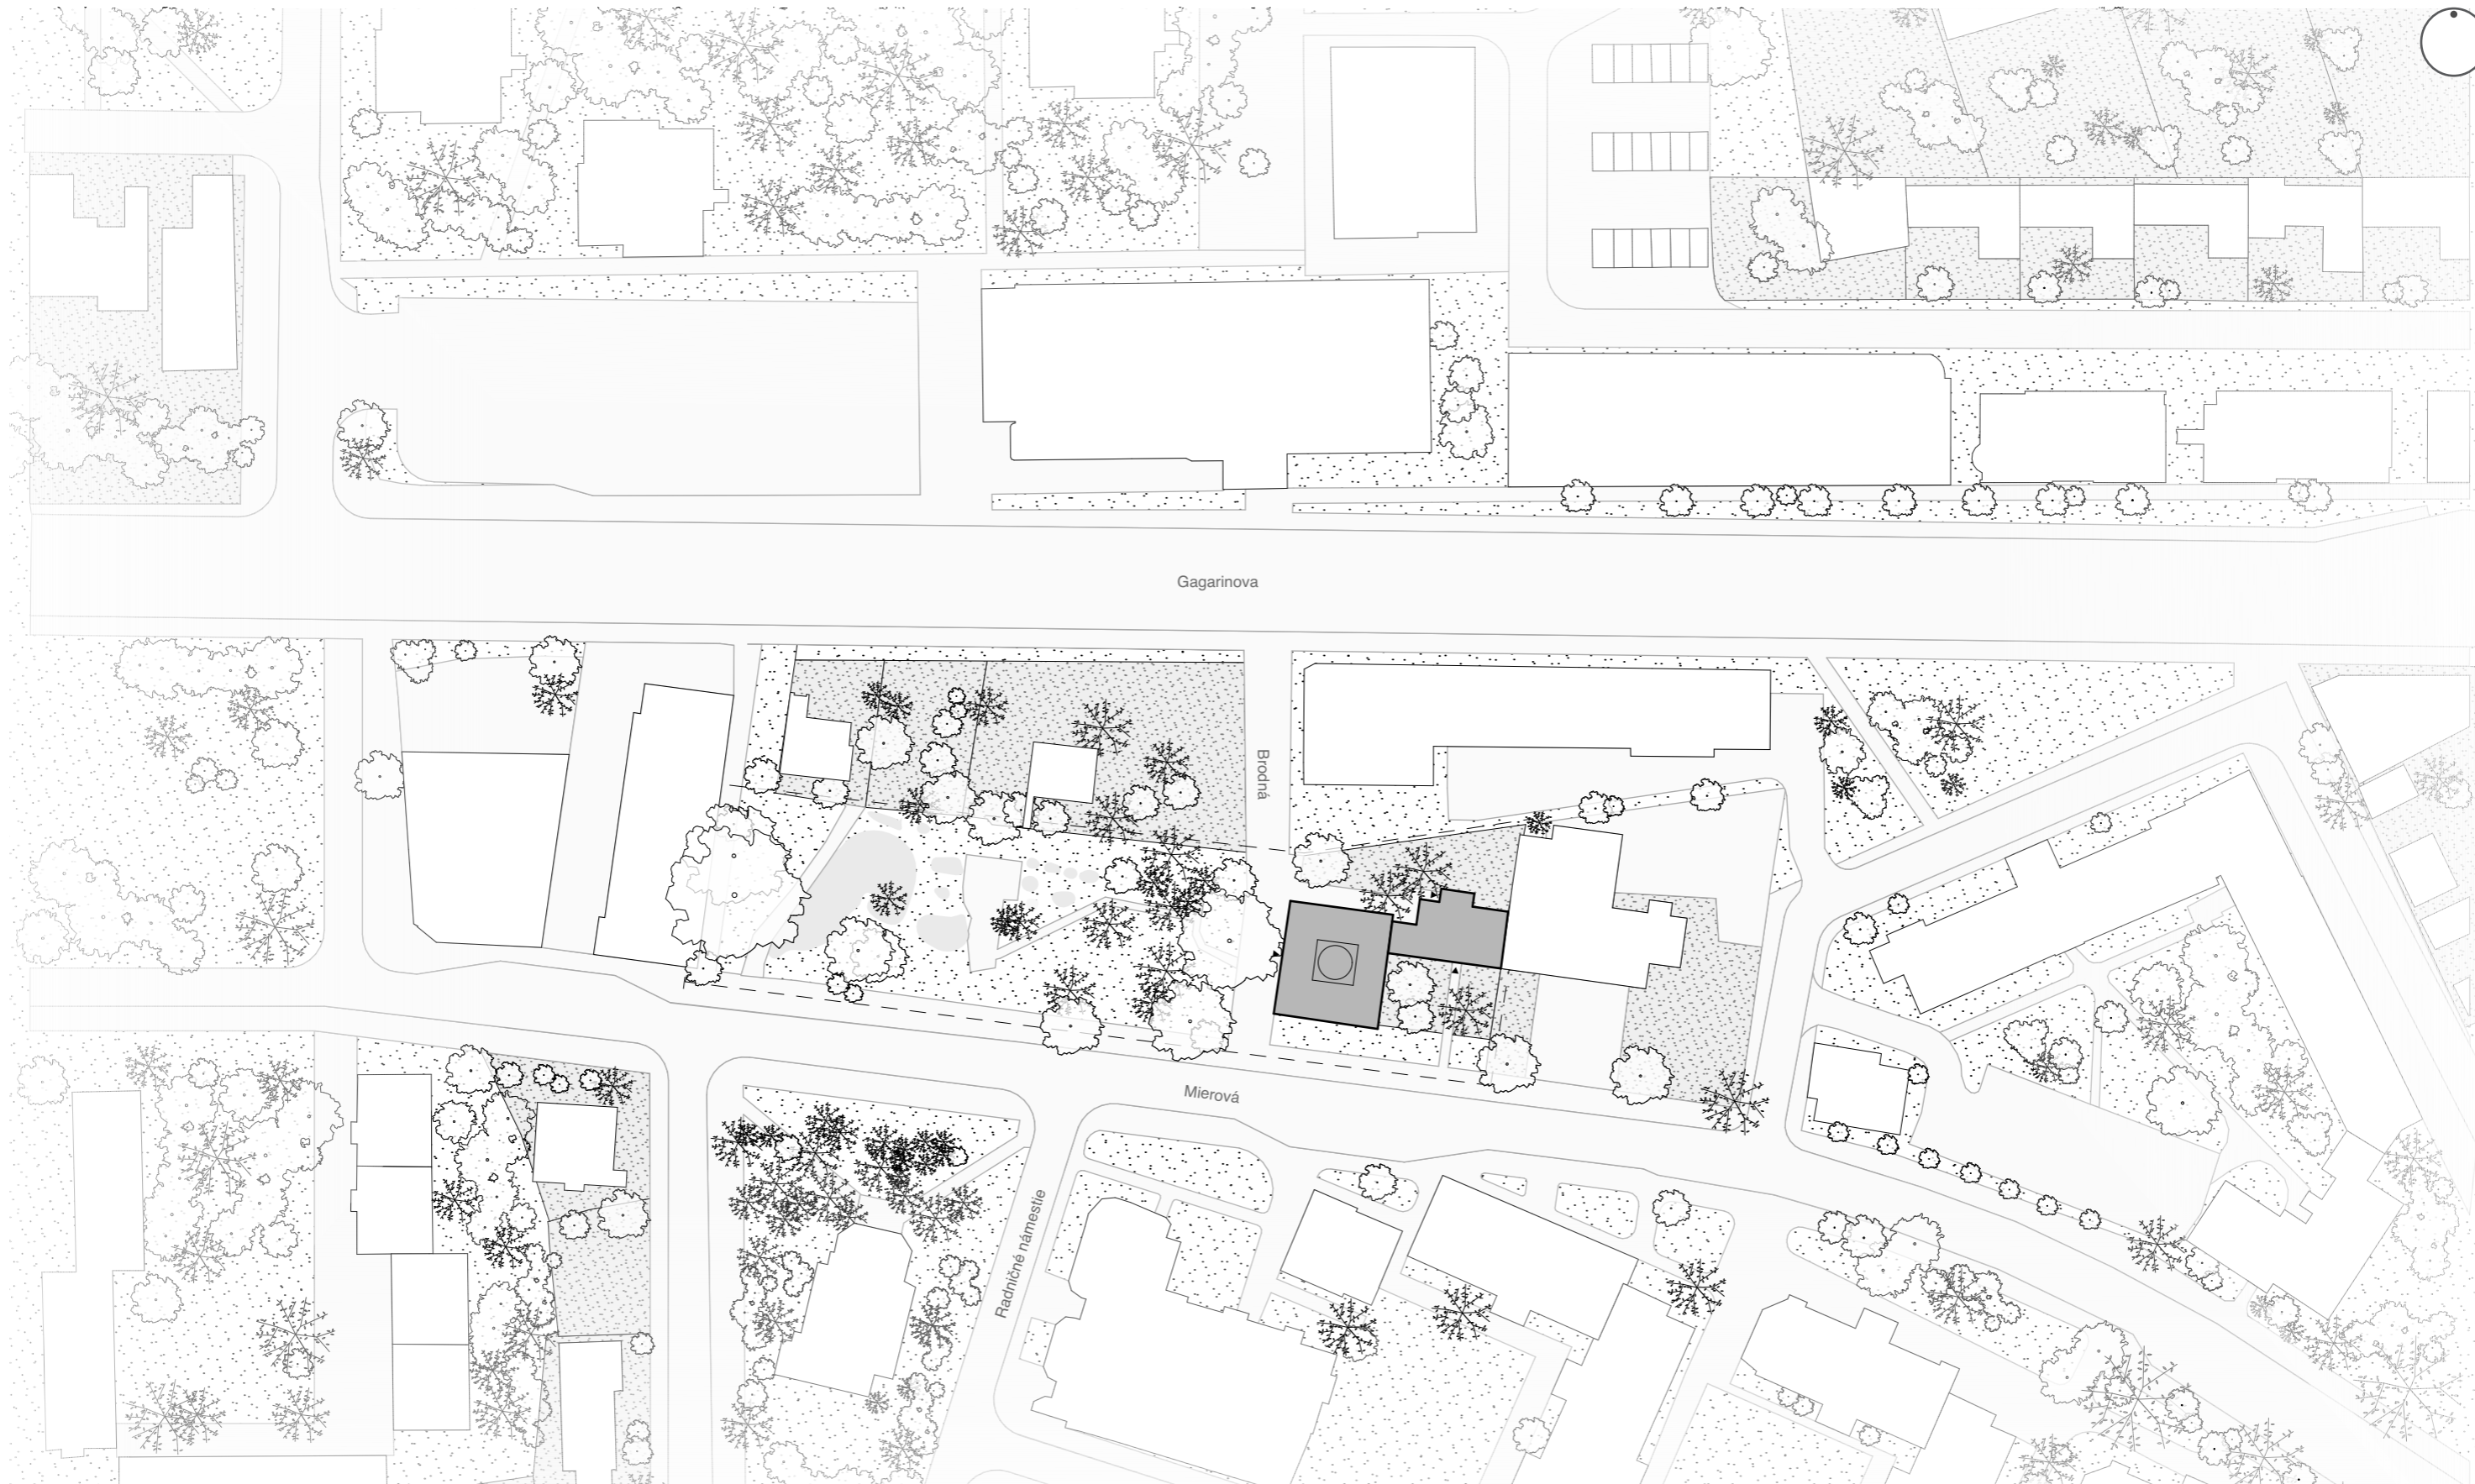
Pri posudzovaní súčasnej výsadby v areáli bolo konštatované, že zastúpenie ihličnatých stromov a tují nie je pre túto lokalitu vhodné, keďže tu prirodzene nemajú optimálne podmienky a esteticky ani ekologicky nezodpovedajú charakteru okolitej krajiny, v ktorej by mali dominovať listnaté dreviny. Z hľadiska údržby a bezpečnosti je zároveň nevyhnutné zamerať pozornosť na stromy, ktoré sú v zlom stave. Konkrétne ide o liesku tureckú, ktorá je suchá, lipu malolistú, ktorá vykazuje známky výrazného zhoršenia zdravotného stavu, a slivky čerešňoplodé, z ktorých ostali už len torzá. Ostatné listnaté dreviny sú v dobrom stave a nevyžadujú si bezprostredný zásah. V okolí sa nenachádzajú žiadne chránené stromy, ani stromy s historickou hodnotou.

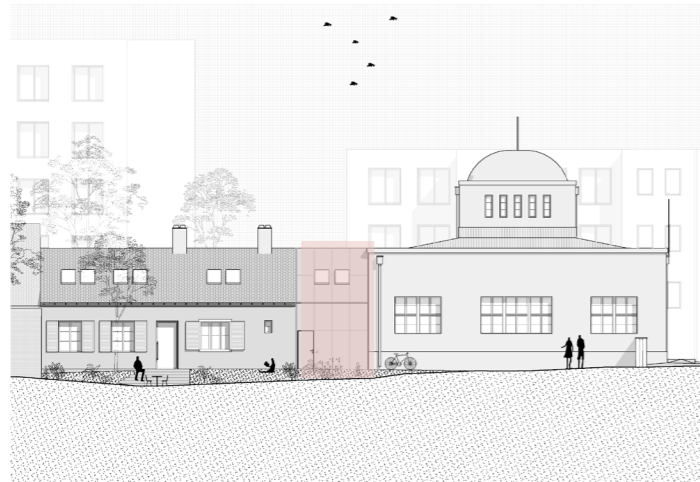
northern facade - modification and completion of the original tectonics of the Notary's House

modification of the original concept of the Notary's House

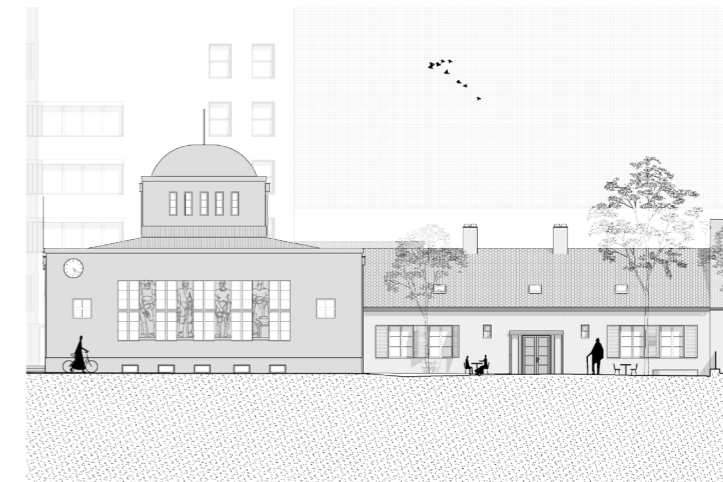
southern facade - restoration of the original appearance of the Town Hall and the Notary's House
