Hidden Plant

Universita luav di Venezia

Corso di Laura Magistrale MA Architecture

This thesis focuses on the renovation of the abandoned Casalmoferto cement plant, located in the western part of the Giudecca island in Venice. The site holds historical significance as one of the earliest and most advanced Portland cement factories in Italy, symbolizing the industrial evolution of Giudecca and its role in regional development. Over the centuries, the area transformed from a monastic garden to an industrial hub and later became a predominantly residential district. The project proposes to convert the former industrial complex into a multifunctional cultural center, integrating preserved industrial buildings and architectural elements into a unified composition. The implementation of the project will connect all historical layers of the site, creating a harmonious space that respects and preserves its multilayered heritage while introducing contemporary functions that support cultural growth and the sustainable development of Giudecca Island.

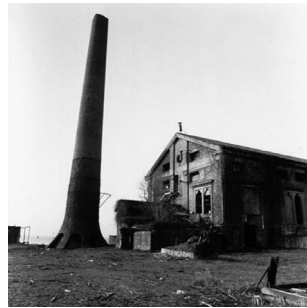
Figure 18
Unknown photographer. [Photograph of the cement factory]. (n.d.).

The plant's design was developed by the Danish engineering firm F.L. Smidth & Co. (Copenhagen). Construction began in 1902, following municipal approval to build a wooden bridge over the San Biagio canal to connect the site. Spanning over 20,000 m², the factory occupied a significant portion of the limited land available in Venice, despite challenging ground conditions.

The production process was complex and largely automated, involving multiple stages: delivery of limestone from Istria and clay from the lagoon, drying, grinding, dosing, mixing, firing in rotary kilns, cooling, further grinding, and final packaging. The plant's designed annual capacity ranged between 300,000 and 500,000 quintals (approximately 30,000 to 50,000 tons) of cement. At its operational peak, the facility employed around 150 workers.

The foundation work posed a complex engineering challenge due to the soft Venetian soil. To ensure stability, the buildings were constructed on reinforced concrete slabs, 20–25 cm thick, supported by conical concrete piles measuring 1.5 meters in length. This solid base was necessary to support the heavy machinery and industrial structures of the plant.

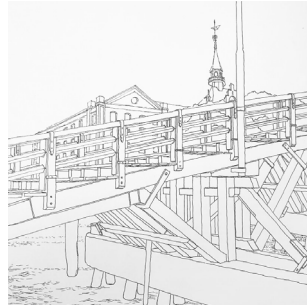
Figure 23
Unknown author. Perspective drawing [Ponte dei Lavraneri bridge]

A notable infrastructural element near the site is the wooden Ponte dei Lavraneri bridge (3), constructed in the 1960s. Supported by six piers, the bridge exemplifies traditional Venetian building techniques, executed without formal static calculations, consistent with the artisanal approaches characteristic of similar lagoon structures.

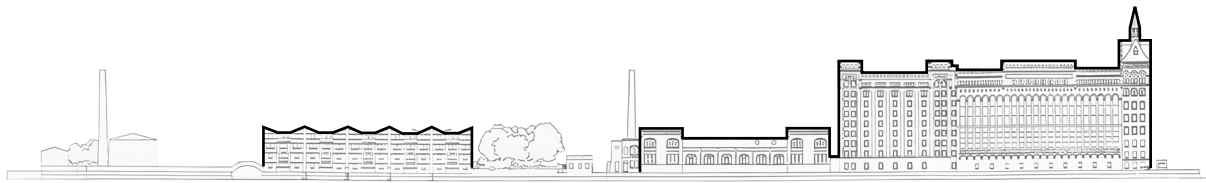
Figure 34
Based on: L'Industria delle Costruzioni. (1987). Facade drawing [Print edition, No. 186, April]. Archive of Gino Valle. Author's own modification: [Igor B], 2025.

To enrich the spatial rhythm and articulation, the façades incorporate alternating vertical and horizontal elements alongside variations in depth — including projections, loggias, and arches. These features define the boundaries of the residential complex, emphasizing its distinct character while maintaining integration with Giudecca's historic context.

The established façade line also serves to orient and enclose the interior spaces, fostering a comfortable living environment that maximizes views toward the lagoon and preserves a harmonious dialogue between built form and the natural landscape.

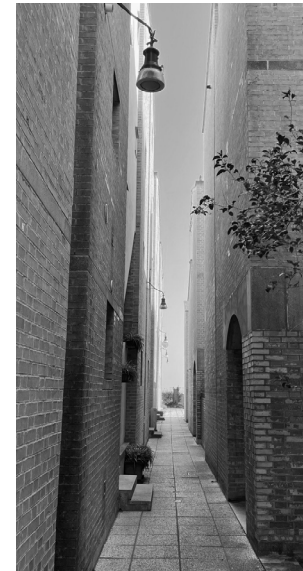
Figure 37
Bychkov, I (2024). *Visual Axis n1* ["Casa alla Giudecca", Giudecca, Venice]

This residential project became a notable example of social housing in Venice, praised for its architectural quality and sensitive adaptation to the local context. A defining compositional feature of the complex is the presence of three through-passages that establish visual and functional connections between the lagoon and the internal spaces of the development. Notably, one of these passages is aligned towards the preserved chimney of the former cement factory, emphasizing and preserving this historical landmark and maintaining a tangible link to the site's industrial heritage. Gino Valle's architectural approach reveals careful consideration of building orientation, optimizing natural light and lagoon views while fostering a comfortable living environment focused on interior spatial quality. The complex's rational layout skillfully balances functionality and aesthetic expression, embodying modernist principles thoughtfully adapted to the unique Venetian context.

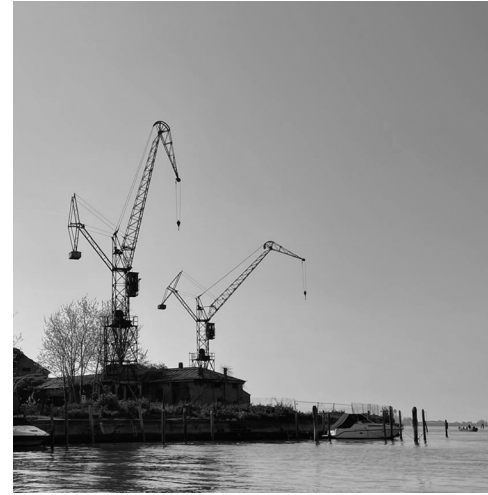
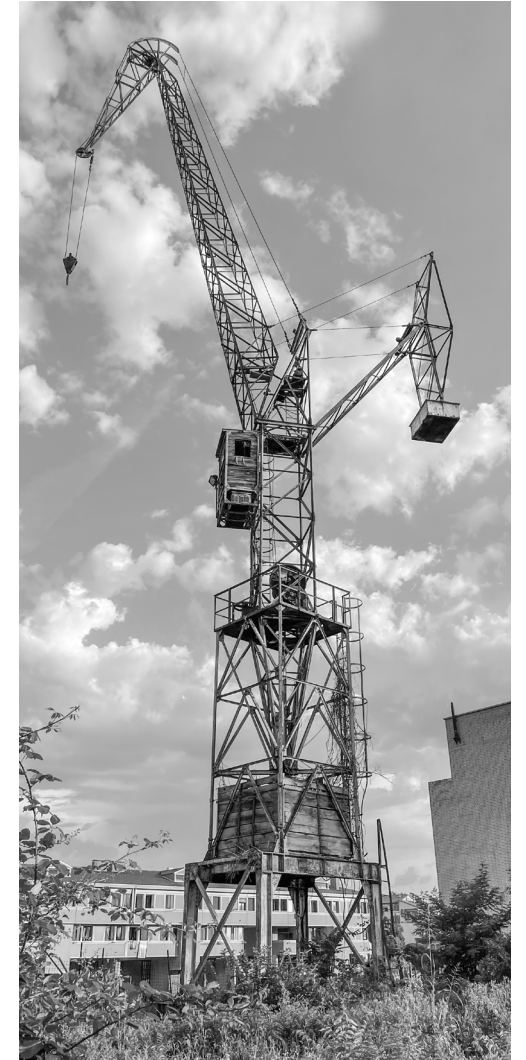
Two old cranes tower over the site like motionless giants. Their massive silhouettes define the vertical dimension of the entire space. There is a sense that activity finished only recently and traces of human presence still remain.

Analysis indicates that no such cranes were present during the cement plant's original operation. These structures were installed when the site was repurposed in the mid-20th century to accommodate the shipbuilding activities of Scalera Trevisan. The cranes remain in relatively good condition, although no information is available regarding the operability of their mechanisms.

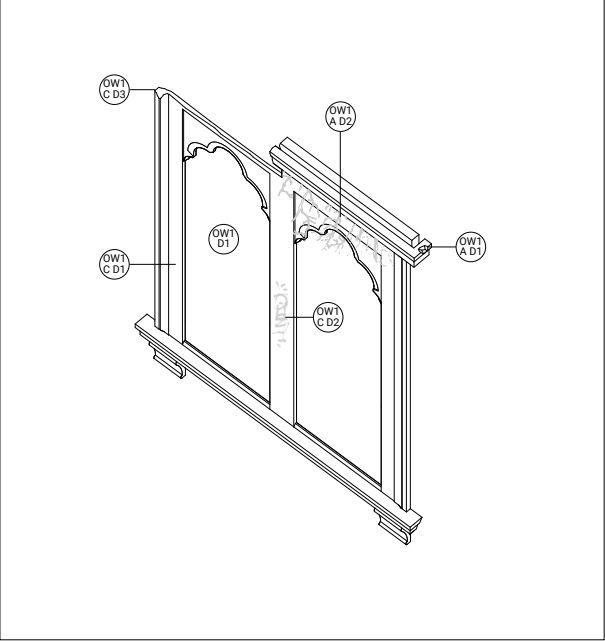
Windows type 01	OW1 D1			
			Physical modification	External damages	Missing glazing
OW1 A

D1 Physical modification D2 Biological degradation

D1 External damages D2 Biological colonization		
			D1 Chipping D2 Higher plant		
			D1 Physical modification D2 Anthropogenic modification D3 Physical modification		
			D1 Moisture absorption, Drying D2 Human intervention D3 External damages		
			D1 Cracks D2 Graffiti D3 Chipping

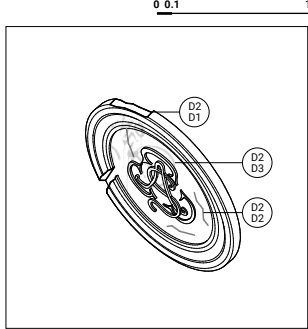
ELEMENT	CODE	PATTERN	DETERIORATION	CAUSES	PHENOMEN
Rosette	D2 D1

Physical modification	Moisture absorption, drying	Cracks
	D3

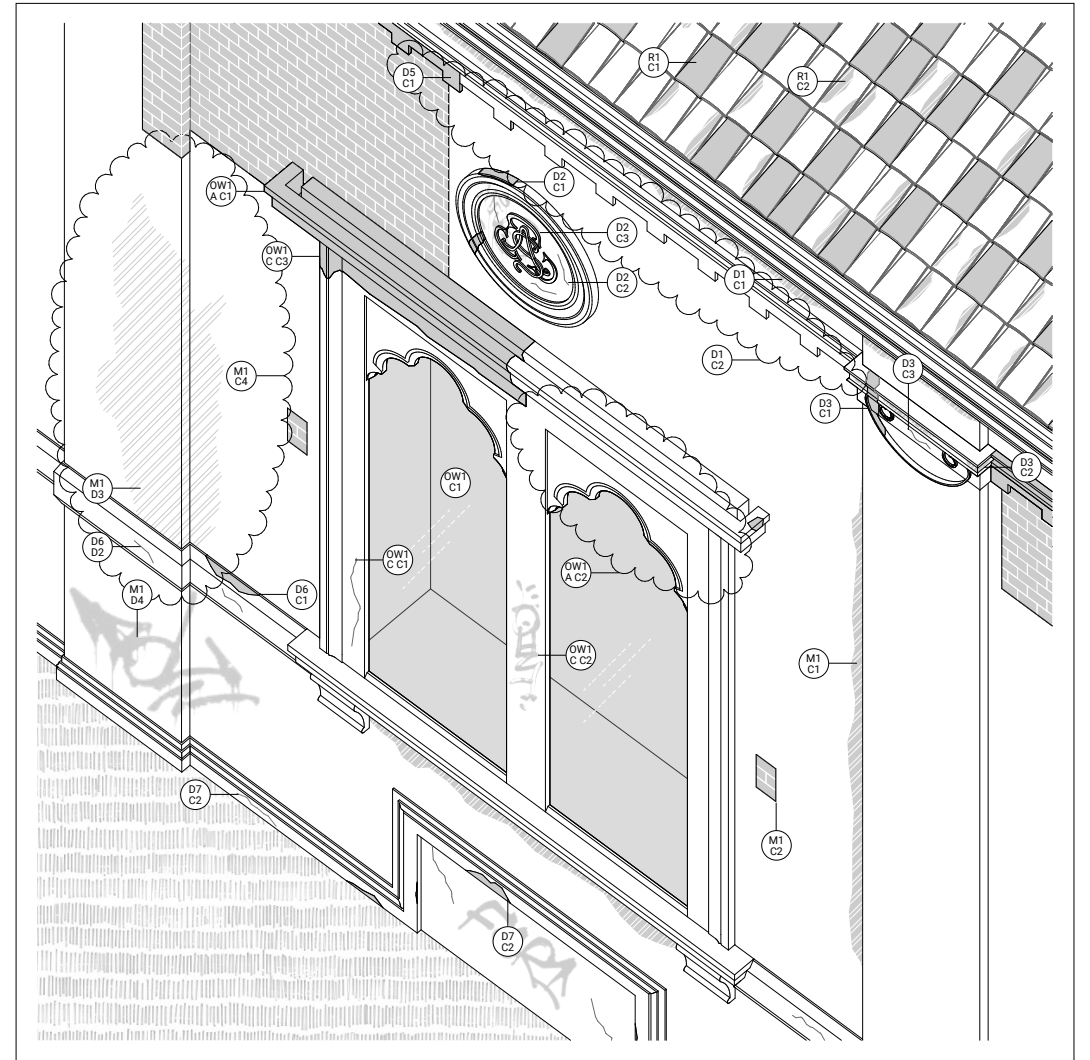
ELEMENT	CODE	CONSERVATION METHOD	DESCRIPTION
Roof covering	R1 C1	REPLACEMENT	The most damaged tiles were replaced with new ones. An additional water-proofing layer was applied.
	C2	CLEANING + PROTECTING COATINGS	Tiles affected by black crust were first cleaned either chemically using antiseptics or mechanically, followed by a protective treatment with hydrophobic and antiseptic properties.
ELEMENT	CODE	CONSERVATION METHOD	DESCRIPTION
Roof battens	R2 C1	REPLACEMENT + PROTECTING COATINGS	The most rot-prone wooden battens were replaced with new elements of the same dimensions, while the remaining battens were treated with oil impregnation to protect against moisture and rot.
ELEMENT	CODE	CONSERVATION METHOD	DESCRIPTION
Secondary structure	R3 C1	REPLACEMENT + PROTECTING COATINGS	The most affected wooden beams were replaced with new elements matching the original dimensions, and others received oil impregnation for protection.

ELEMENT	CODE	CONSERVATION METHOD	DESCRIPTION
Primary structure	R4 C1	CLEANING + PROTECTING COATINGS	The corroded metal truss was mechanically cleaned to remove rust deposits, treated with an anti-corrosion primer, and coated with a protective paint layer.
M - MASONRY WALL			
ELEMENT	CODE	CONSERVATION METHOD	DESCRIPTION
Regular masonry bricks	M1 C1	CLEANING + PROTECTING COATINGS	Black crust was removed from the brick masonry using controlled mechanical cleaning, low-pressure micro-abrasion, or soft brushing, ensuring no damage to the original brick texture and mortar joints.
	C2	REINTEGRATION	Missing parts of the brick wall were reintegrated using new brick masonry compatible in size and composition, aligned with the existing bond pattern, with new work distinguished by slight variations in color or texture.
	C3 / C4	REMOVAL + CLEANING + PROTECTING COATINGS	Higher vegetation and roots were removed from the surfaces, followed by gentle mechanical and chemical cleaning to eliminate biological patina and deposits. A breathable protective coating was applied to reduce moisture retention and prevent regrowth.
