ASWAN · EGYPT

RE:MNANT

The Aswan High Dam stopped the Nile flood in 1970. With it went the only germination trigger five native riparian species on Salsiga Island ever had and the natural snail control that kept Bilharzia out of Aswan's irrigation canals. Remnant puts the flood back: five stone basins staggered by elevation across the island's granite, each flooding for the exact duration its species needs, feeding a linear production chain that sends seedlings, seed stock, and fodder downstream by felucca, no mechanical systems, no grid connection, only topography and a notch in a wall. Remain. Return. Regenerate.

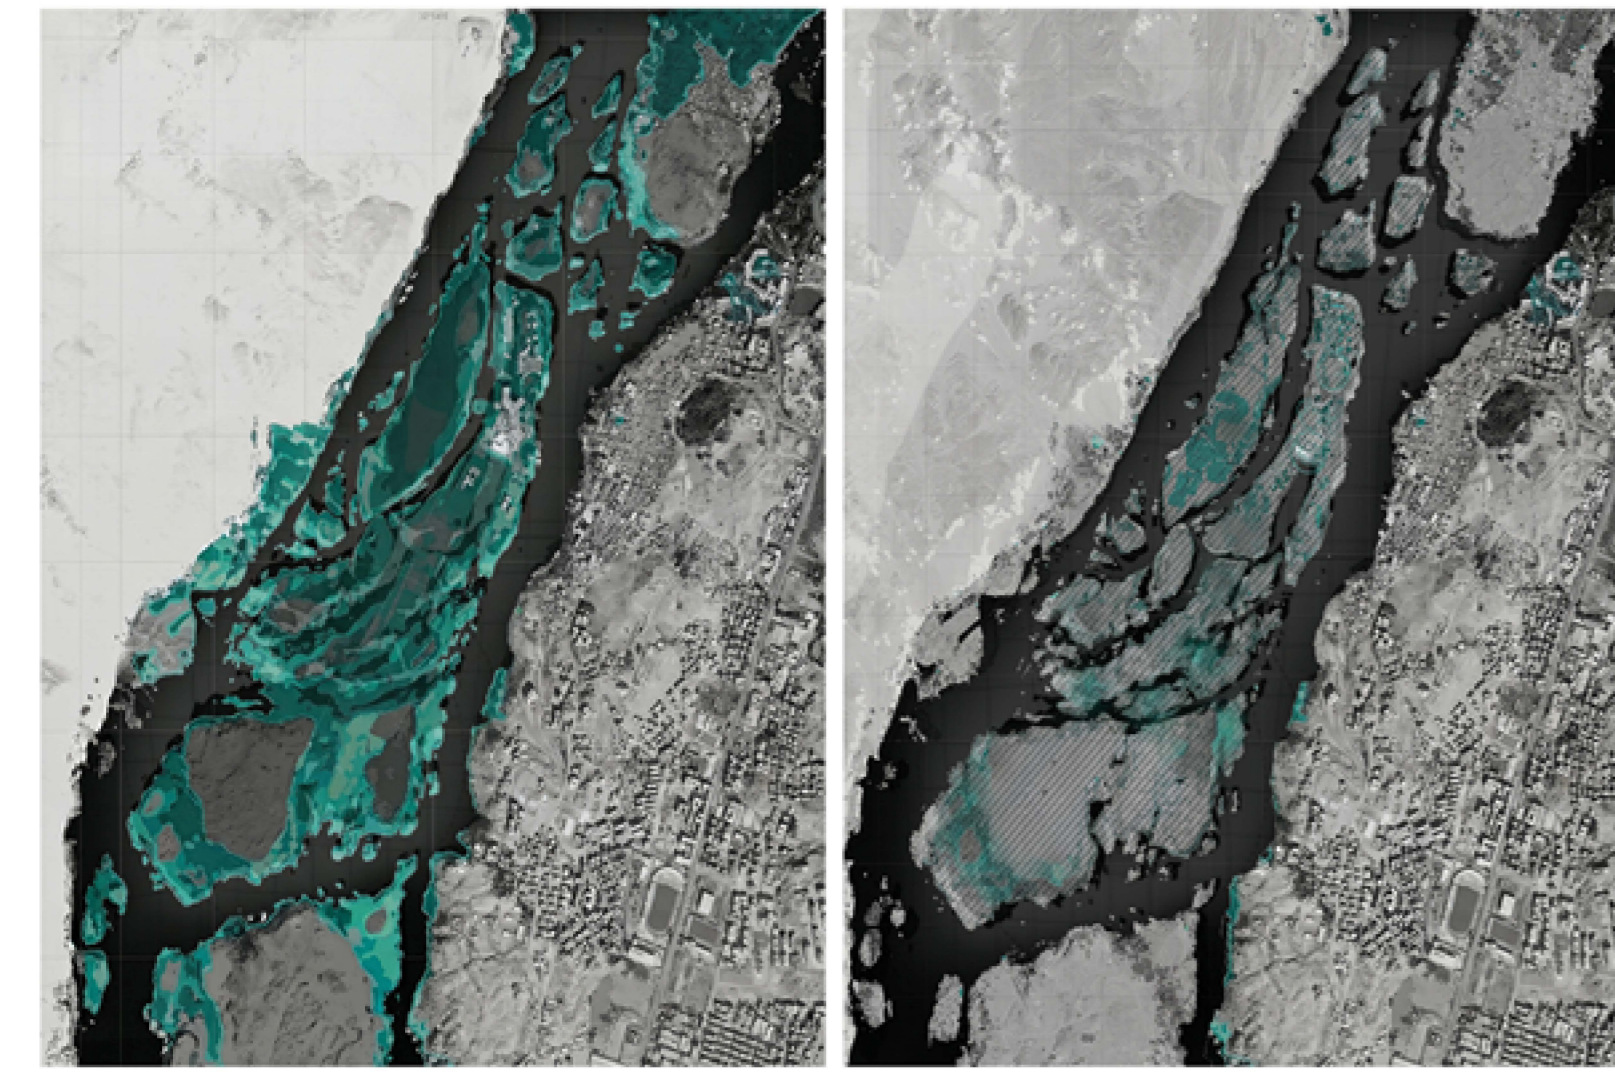
Vegetation Drop
 Silt and Sediments Absence
 Base stage up until 2009 with all plants still maintaining regular reproduction. Current state is suffering a whopping 65% loss in total vegetation leaving some species endangered.
